**TV INSPECTION OF SWEETWATER SUBDIVISION Township 29 Section 17 Range 12**

# Sweetwater Subdivision Stormwater Drainage

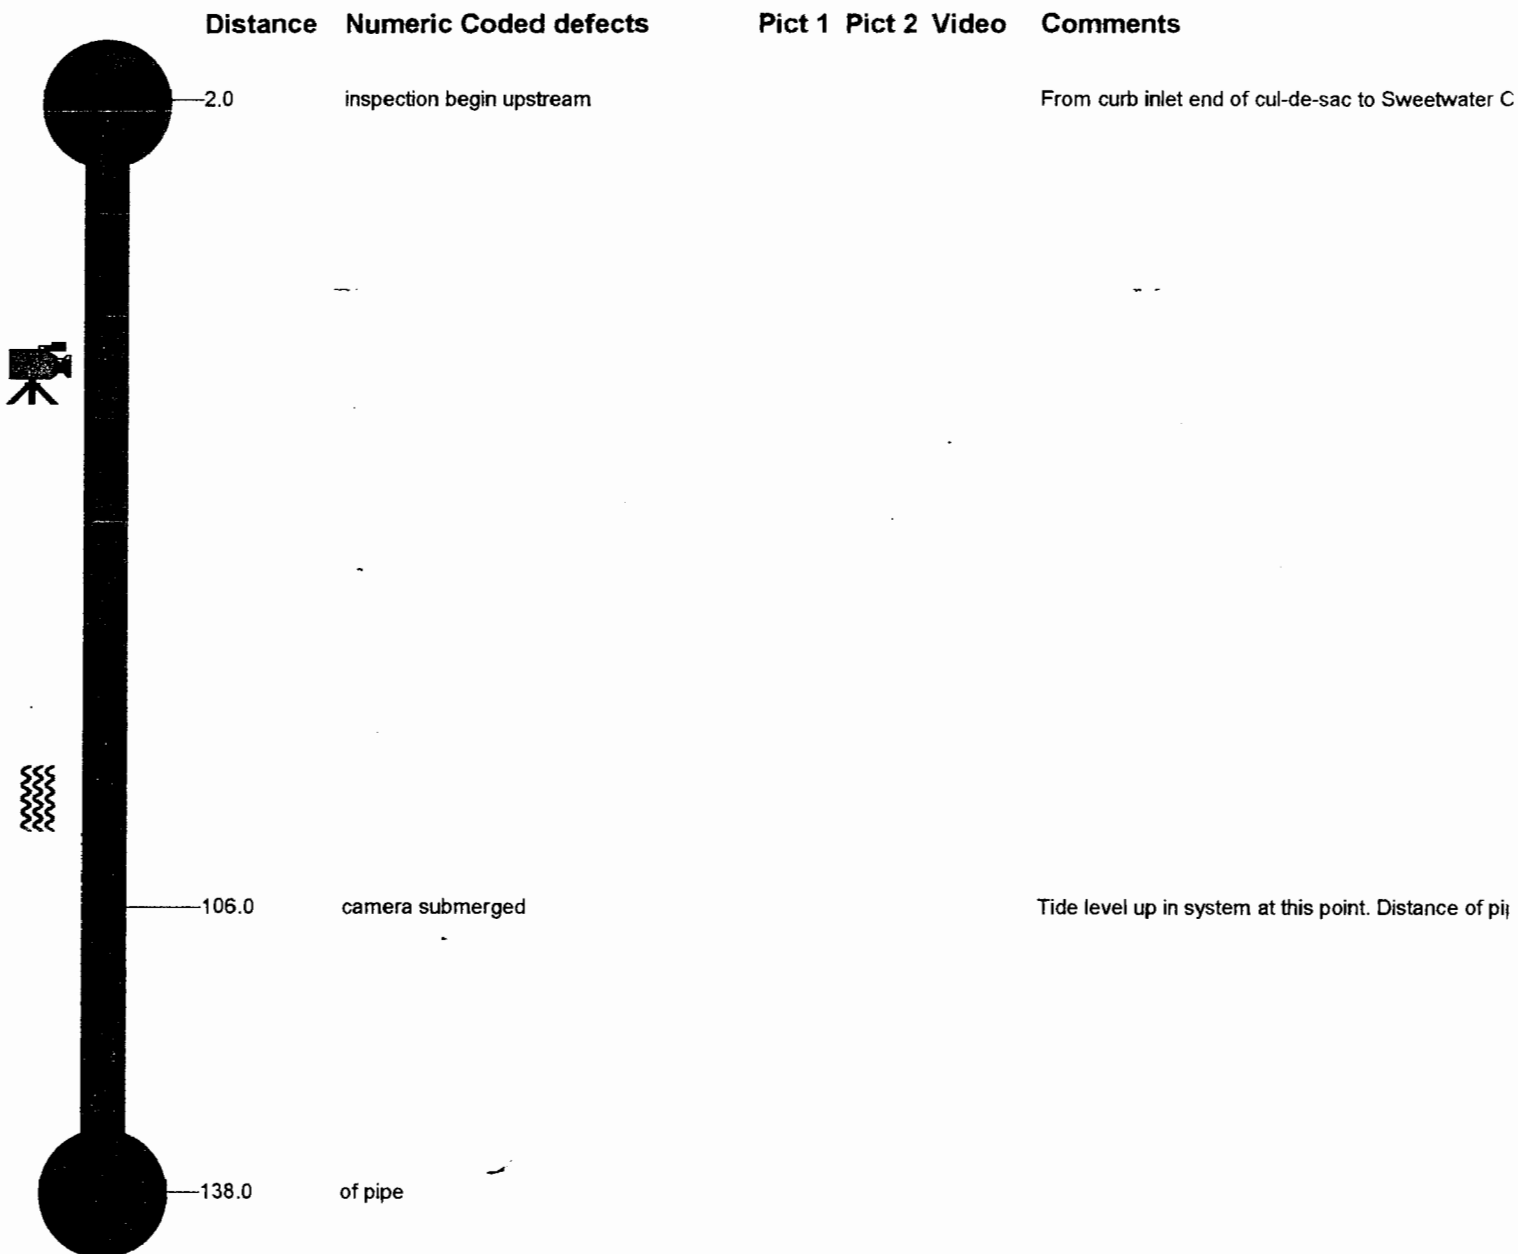
Site ID	City	Street	Date	Time
2	Town & Country	4307 Saltwater Bl	05/28/2003	11:53:57 AM
M.H. Start	M.H. Stop	M.H. Depth	Starting Dist	Final Dist
End of Cul-De-Sac	Sweetwater Creek	3.	2.0	138.0
Type of Pipe	Pipe Size(in)	Sec. lgth	Direction	Surface Condition
Concrete	15	8	DOWNSTREAM	Easement
Operator				
JOHN				
Comment				
System 1A to east (outfall) Sweetwater Creek

Obs ID	Dist	LD	Code / Defect	ClockPos	Sevr Lv	Ph1 ID	Ph2 ID	VclipID	VidID	TapeCnt	Comment
1	2.0		inspection begin upstream								From curb inlet end of cul-de-sac to Sweetwater Creek east
2	106.0		camera submerged								Tide level up in system at this point. Distance of pipe 138 feet
3	138.0		of pipe

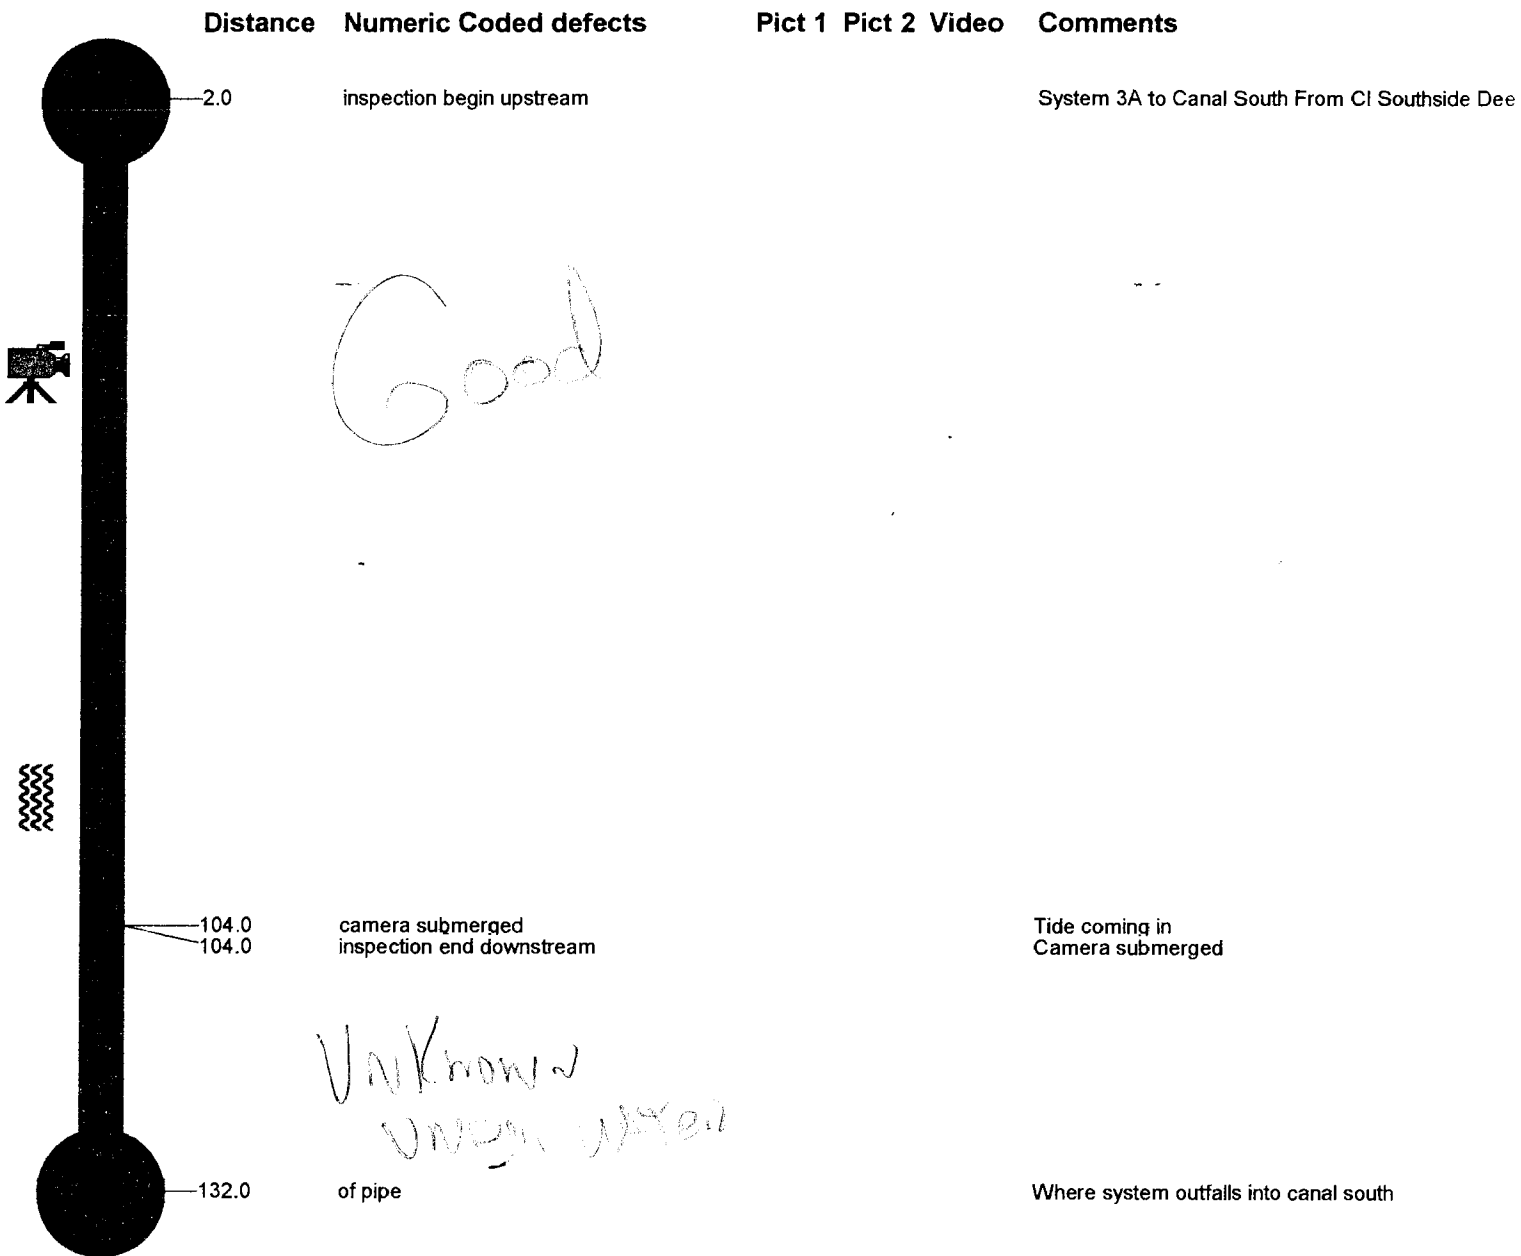
Site ID	City	Street	Date	Time
8	Town & Country	4205 Deepwater Lane	06/02/2003	11:51:04 AM
M.H. Start	M.H. Stop	M.H. Depth	Starting Dist	Final Dist
CI Southside	Canal South	4.	2.0	132.0
Type of Pipe	Pipe Size(in)	Sec. lgth	Direction	Surface Condition
Concrete	15	8	DOWNSTREAM	Easement
Operator				
JOHN				
Comment				
To Outfall (Canal) South / System 3A

Obs ID	Dist	LD	Code / Defect	ClockPos	Sevr Lv	Ph1 ID	Ph2 ID	VclipID	VidID	TapeCnt	Comment
1	2.0		inspection begin upstream								System 3A to Canal South From CI Southside Deepwater Lane
2	104.0		camera submerged								Tide coming in
3	104.0		inspection end downstream								Camera submerged
4	132.0		of pipe								Where system outfalls into canal south

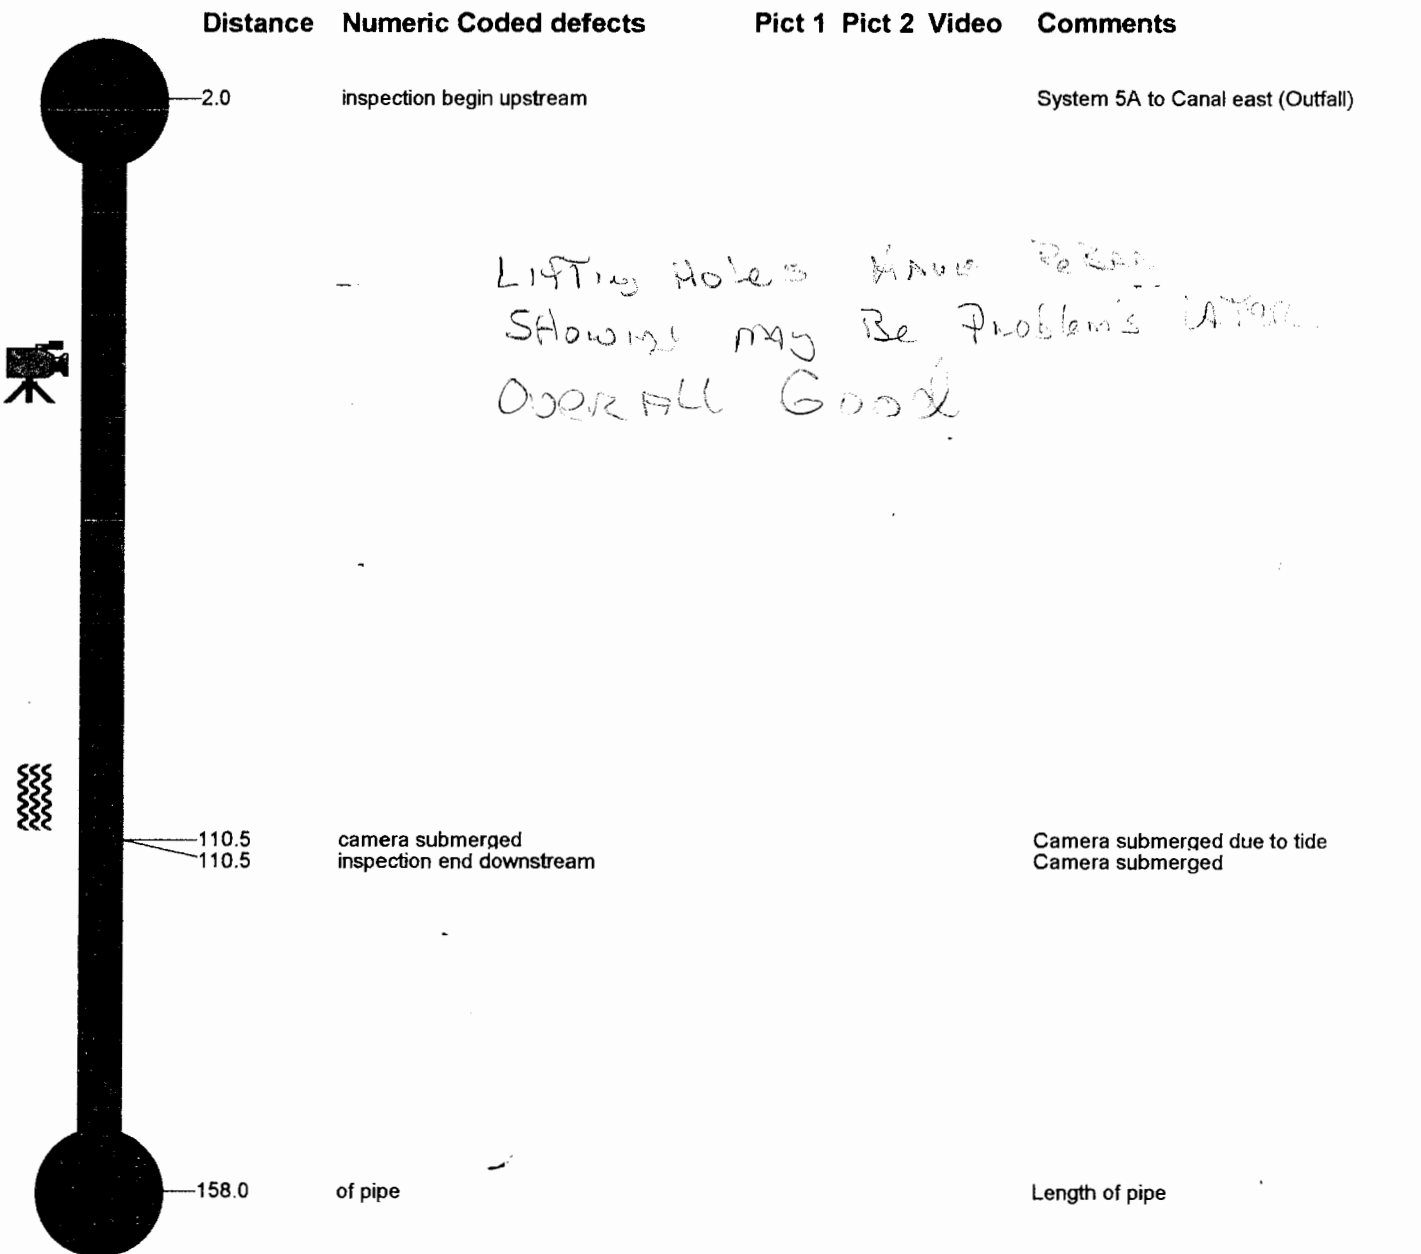
Site ID	City	Street	Date	Time
12	Town & Country	4173 Saltwater Bl	06/03/2003	10:40:47 AM
M.H. Start	M.H. Stop	M.H. Depth	Starting Dist	Final Dist
CI Eastside	Canal East	4.	2.0	158.0
Type of Pipe	Pipe Size(in)	Sec. lgth	Direction	Surface Condition
Concrete	18	8	DOWNSTREAM	Paved Asphalt
Operator				
JOHN				
Comment				
System 5A to Canal east (Outfall)

Obs ID	Dist	LD	Code / Defect	ClockPos	Sevr Lv	Ph1 ID	Ph2 ID	VclipID	VidID	TapeCnt	Comment
1	2.0		inspection begin upstream								System 5A to Canal east (Outfall)
2	110.5		camera submerged								Camera submerged due to tide
3	110.5		inspection end downstream								Camera submerged
4	158.0		of pipe								Length of pipe
