**TV INSPECTION OF SWEETWATER SUBDIVISION Township 29 Section 17 Range 12**

# Sweetwater Subdivision Stormwater Drainage

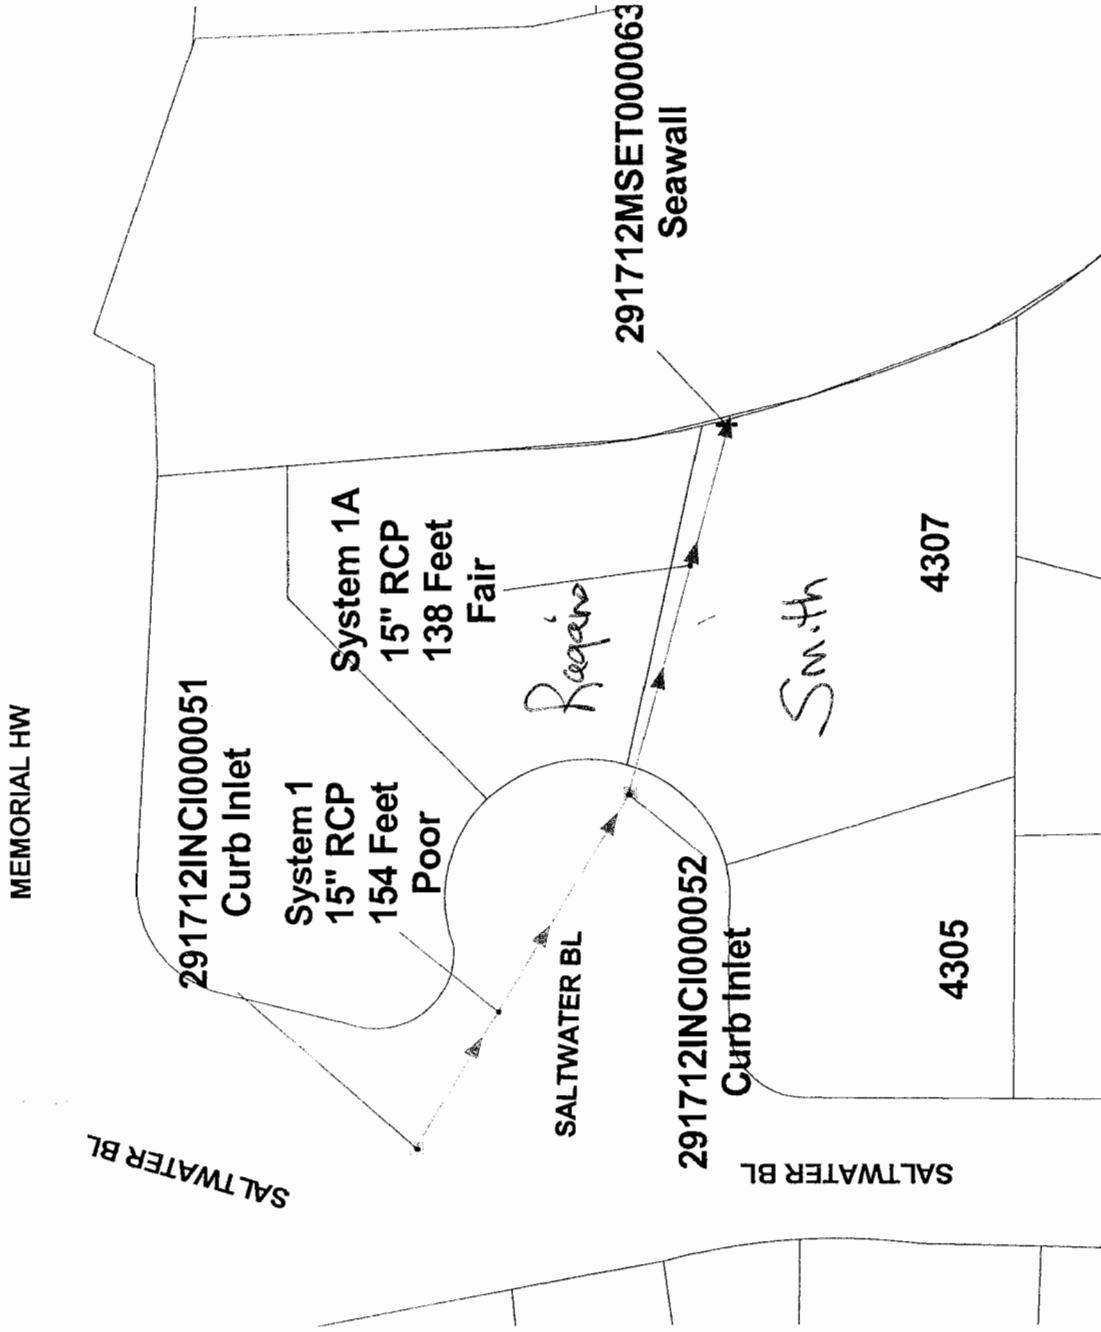
## System 1

Distance	Numeric Coded defects	Pict 1	Pict 2	Video	Comments
2.0	inspection begin upstream				System 1 draining to east to sweetwater creek
31.3

leaking lift hole
47.0

leaking lift hole
112.5	pipe cracked

pipe cracked & soil intrusion
151.2	inspection end downstream				Camera stops dirt in pipe. CI at cul-de-sac 4ft ahead
154.0	of pipe				distance of pipe

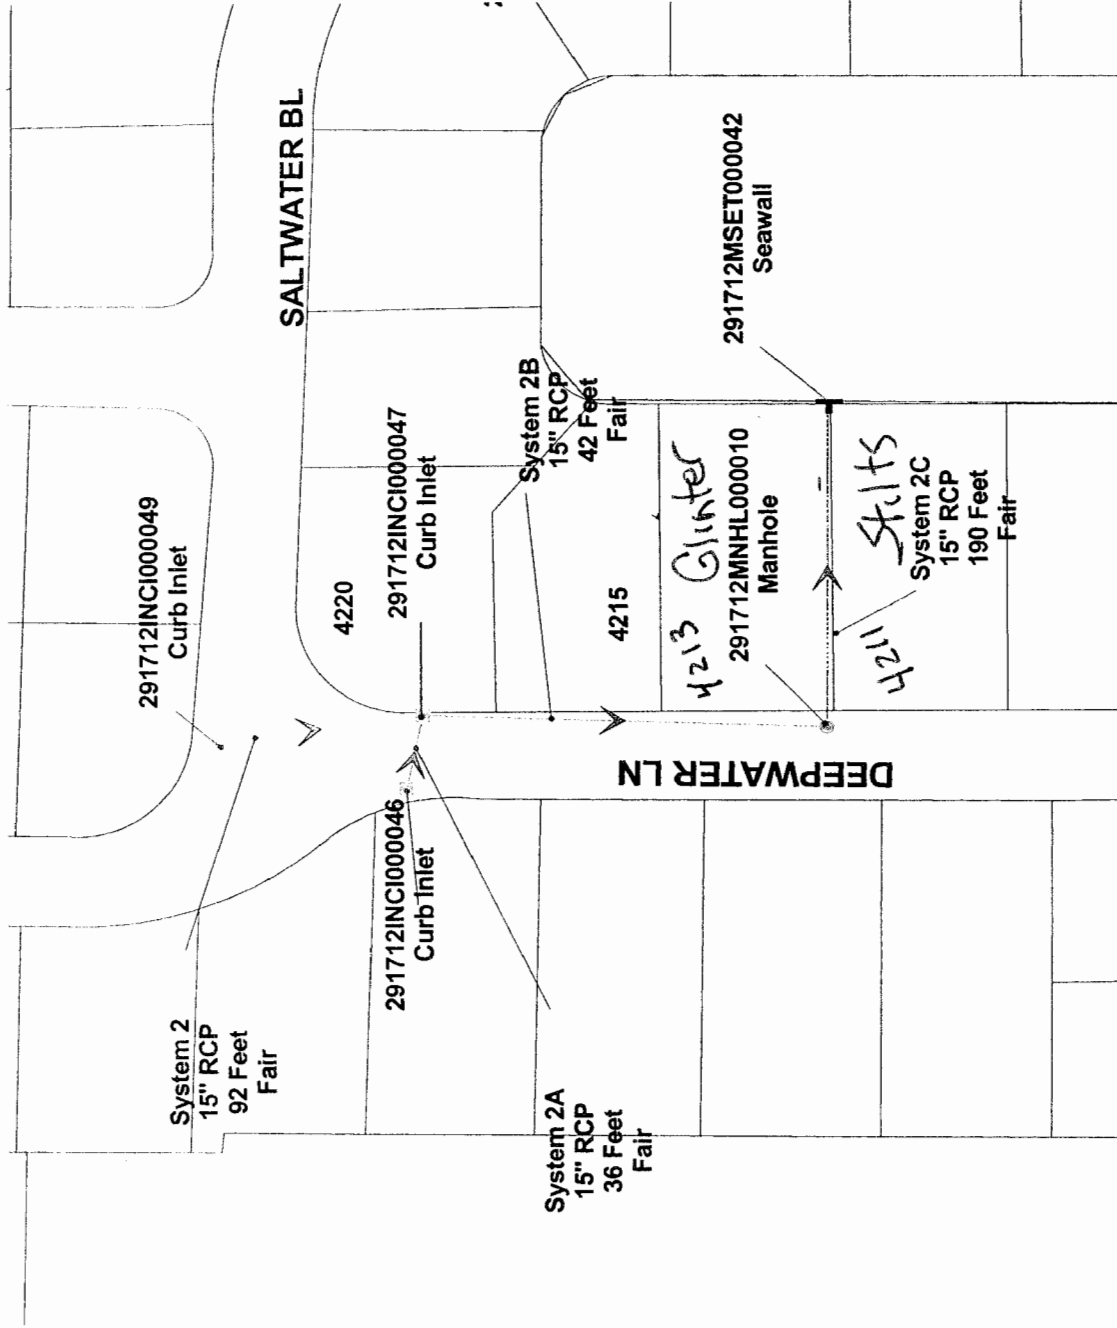
Distance	Numeric Coded defects	Pict 1	Pict 2	Video	Comments
2.0	inspection begin downstream  CRACK 5 FT  CRACK 3 FT				System 2 Intersection Saltwater Bl / Deepwater La
59.4	camera blocked				Rock in pipe
92.0	of pipe				CI NE Corner of Intersection
